ACCIONA  
Waubra Wind Farm

**ELECTRIC LINE CLEARANCE  
MANAGEMENT PLAN (ELCMP)  
2018/2019**

- Rev 5.2
- Date Issued: July 2018

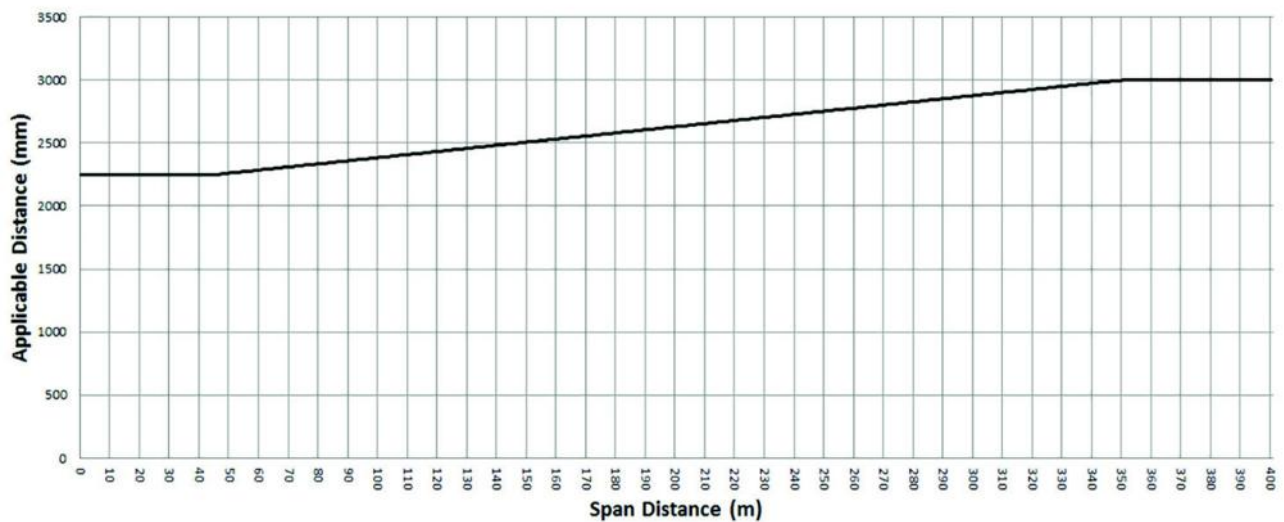
**GRAPH 6  
UNINSULATED 66,000 VOLT ELECTRIC LINE ON HAZARDOUS BUSFIRE AREA**

The schedule to the Code specifies the minimum clearance space around electric lines that the Responsible Person must maintain. Waubra Wind Farm is located in a “hazardous bushfire risk area” and uses only uninsulated electric lines operated at 66 kV. Consequently it is only ‘Graph 6, ‘Figure 1’ and ‘Figure 5’ which are relevant to this ELCMP. These tables and figures are reproduced below for convenience of the reader (reference should always be made directly to the Code in case changes have been made).

The formula by which the applicable distance for the middle two thirds of a span of an electric line to which clause 29 applies is calculated is as follows:

(4) The applicable distance for the first and last sixths of a span of an electric line to which clause 29 applies is 2250 millimetres.

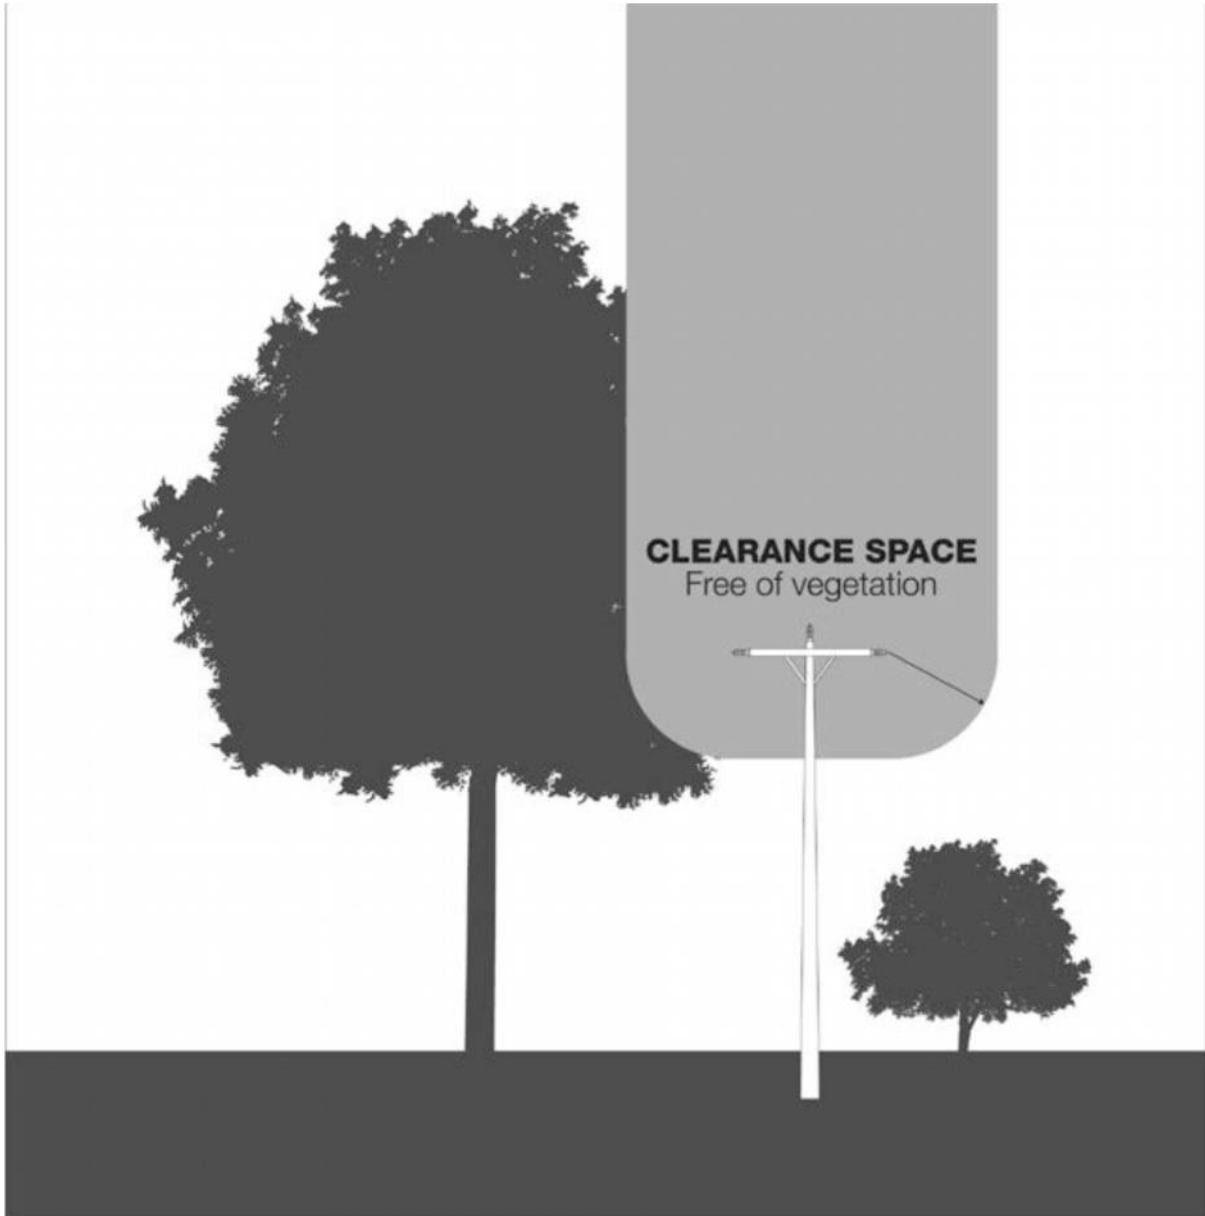
**FIGURE 5:**

UNINSULATED 66 000 VOLT ELECTRIC LINE IN A LOW BUSHFIRE RISK AREA AND  
UNINSULATED ELECTRIC LINE IN A HAZARDOUS BUSHFIRE RISK AREA
