Warrell Creek to Nambucca Heads – Pacific Highway Upgrade Project

ENVIRONMENT PROTECTION AUTHORITY MONTHLY REPORT

■ March 2015

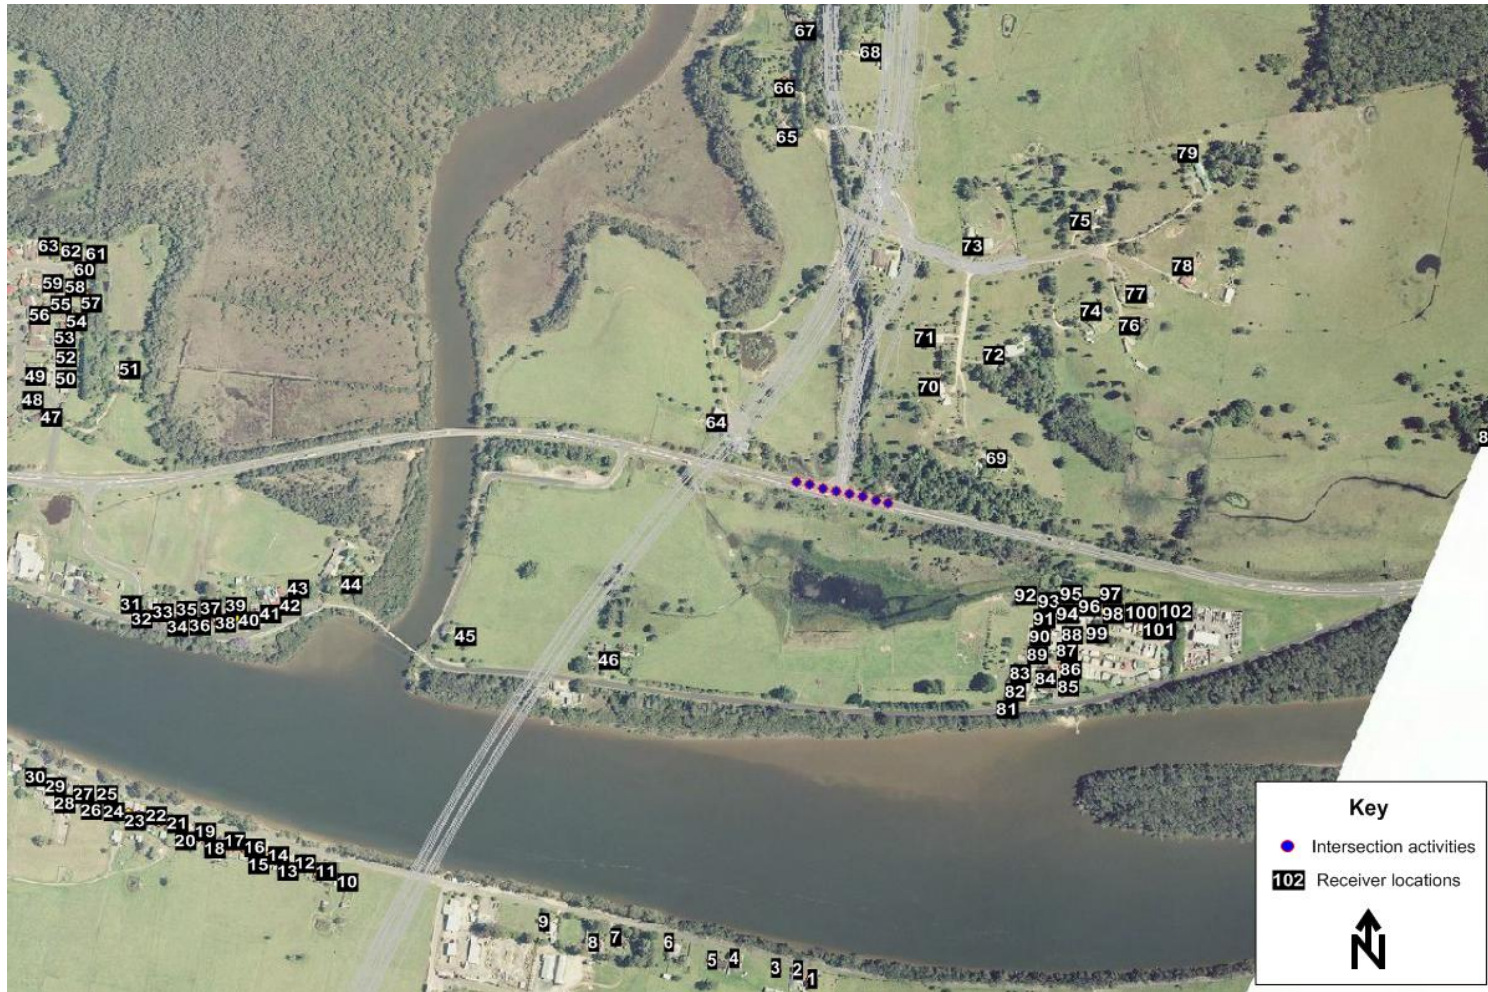
Figure 1 Source and receiver locations

To evaluate potential noise impacts arising from the intersection upgrade works the activities were modelled using SoundPlan version 7.3. Noise impacts were calculated using the CONCAWE prediction method. The following components were incorporated in the model:

Noise levels were predicted at the nearest receivers shown below in **Figure 1**. Receivers 1 to 30 are located within noise catchment area (NCA) 3 and receivers 31 to 102 are located in NCA 4 as defined in the *Noise and Vibration Management Sub Plan (NVMP)*, (PAF JV / Jacobs, September 2014).

The noise levels calculated in **Table 2** were all found to be at or below the NMLs at each of the nearest receivers.

An assessment was completed using SoundPlan version 7.3 to evaluate whether noise impacts were likely to result from upgrade activities around the intersection of the Pacific Highway and Old Coast Road. Predictions indicated that NMLs were not likely to be exceeded at any of the nearest 102 receivers, and as such that no specific noise mitigation measures should be required during the works.
